1940 RAILWAY DISASTER

NORTON FITZWARREN

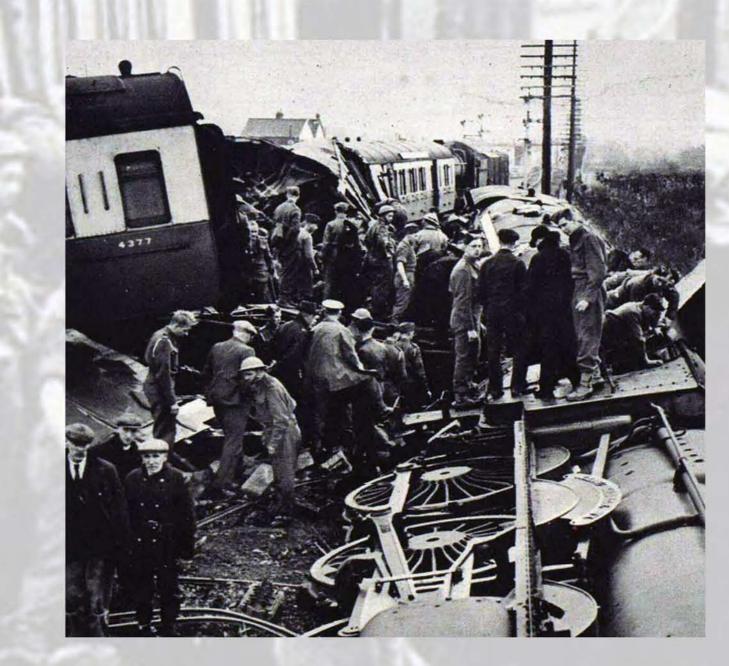
The accident scene

The locomotive and tender were diverted off the tracks and travelled along across the ground, coming to rest on its side 40 metres beyond the last rail of the trap points.

The momentum of the train carried the first two coaches past the locomotive (to its right) coming to rest roughly parallel to each other and diagonally across the Up and Down lines. The third coach was telescoped against the locomotive tender, and the fourth was thrown out to the right. The fifth coach was telescoped for about half its length into the third and the sixth coach was derailed and damaged at the leading end.
